**Investigation of the Plastic Fracture  
of High Strength Steels**

**Department of Metallurgy and Materials Science  
Carnegie-Mellon University  
Pittsburgh, Pennsylvania 15213**

**NASA Technical Report No. 3**

**May 1972**

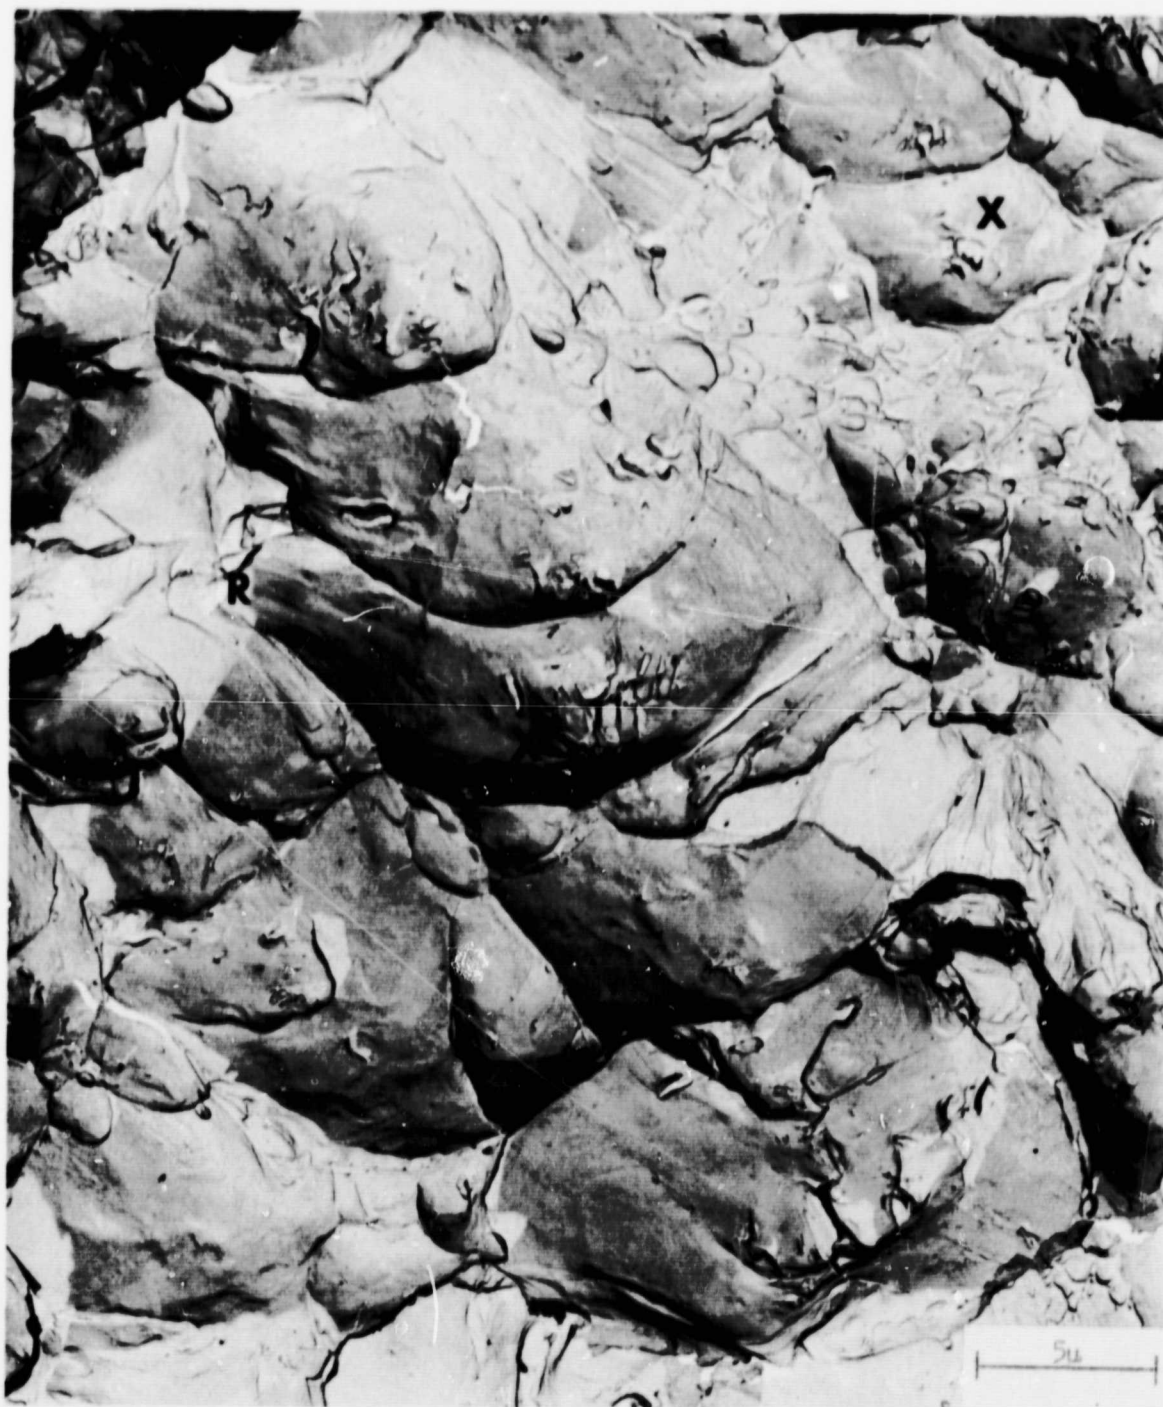
Examination of the 18 Ni maraging fractographs in Figures 6 and 7 reveals the fracture surfaces to be almost completely covered by large dimples approximately 10-20 $\mu$  in diameter. At the positions marked "X" on the fractographs, examples of impressions of carbo-nitride particles may be seen at the bottoms of dimples. The particular carbo-nitride marked "Y" in Figure 7 exhibits a clear cleavage fracture pattern, suggesting that the associated dimple was nucleated by the separation of the halves of the fractured non-metallic inclusion. The other large dimples were also presumably nucleated at carbo-nitride particles, which are either seen within the dimples or have failed to be replicated for some reason.

(Carbo-Nitrides indicated by X; Deformation Markings indicated by R)

Figure 6 Electron Fractograph of Two-Stage Replica from Central Region of Tensile Fracture in Commercial 18 Ni Maraging Steel

At the position marked "R" in Figures 6 and 7, evidence of surface rumpling of the dimple walls is seen. These wavy features are reminiscent of the intense deformation markings on the free surfaces of tensile specimens, which have been strained well into the plastic region. The implication is that the dimple walls were, in fact, free surfaces during a major portion of the plastic deformation of the matrix. It has been observed that these intense deformation markings are more numerous and pronounced for the more ductile high purity 18 Ni, 200 grade maraging alloy than for the commercial alloy, as may be seen by comparison of Figures 6 and 7.

18 Ni, 200 grade maraging fracture surfaces (see Figures 6 and 7), the areas of small dimples were not extensive enough to measure a statistically significant area fraction for the maraging alloys. The maraging fracture surfaces considered as a whole had approximately 100 percent area fraction of large dimples.

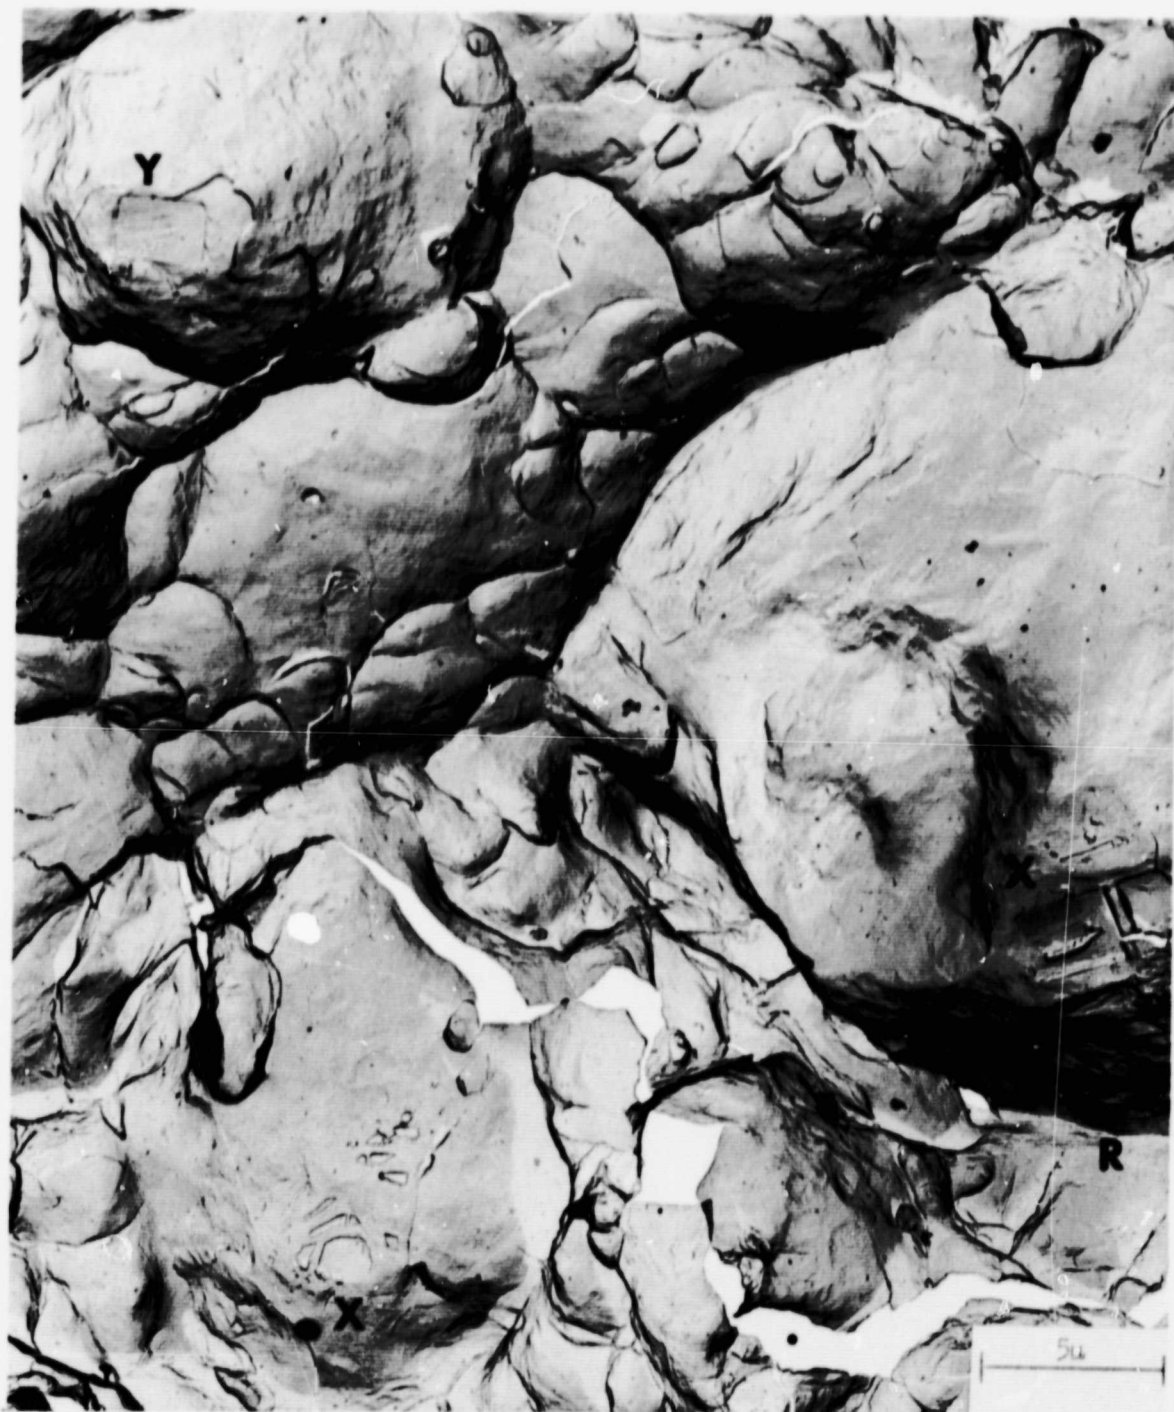
(Carbo-Nitrides indicated by X; Cleavage Fracture Pattern on Carbo-Nitride indicated by Y; Deformation Markings indicated by R)

Figure 7 Electron Fractograph of Two-Stage Replica from Central Region of Tensile Fracture in High Purity 18 Ni Maraging Steel

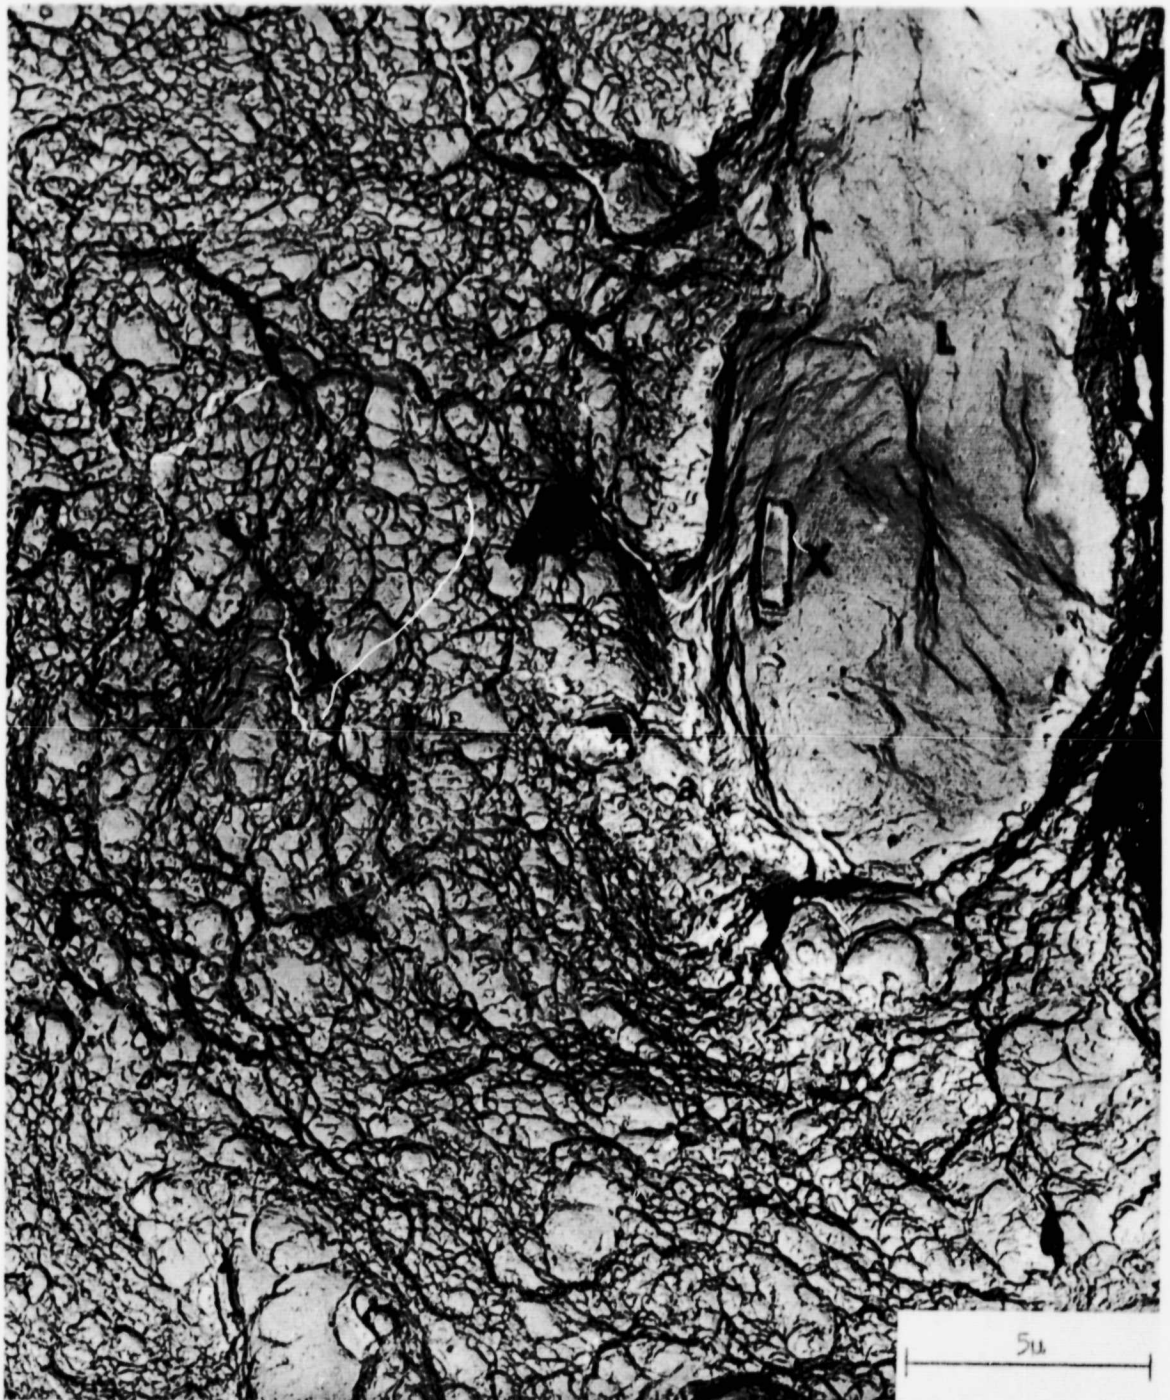
Representative fractographs of the tensile fractures observed in the AISI 4340 alloys are presented in Figures 8 and 9. Each of these fractographs is composed of a large dimple 5-15 $\mu$  in diameter marked with the letter "L" in the figures with the remainder of the area of each fractograph covered with very fine dimples one-to-two orders of magnitude smaller. No fundamental differences between the fractures of the high purity and commercial AISI 4340 alloys could be discerned from their fracture surfaces. Both alloys exhibit extensive surface rumpling on the large dimple walls as was observed in the maraging steels. Careful examination of the areas of fine dimples shows that many of these small dimples contain the impression of a nucleating particle. Likewise, the points marked "X" within the large dimples are most probably the impressions of the nucleating particles for the large dimples. Although the replicated shapes of these particles are not distinctive, their general sizes correspond with those of the manganese sulfide particles identified as the predominate non-metallic inclusions in these AISI 4340 steels.

(Large Dimple indicated by L; Nucleating Particle indicated by X)

Figure 8 Electron Fractograph of Two-Stage Replica from Central Region of Tensile Fracture in Commercial AISI 4340 Steel

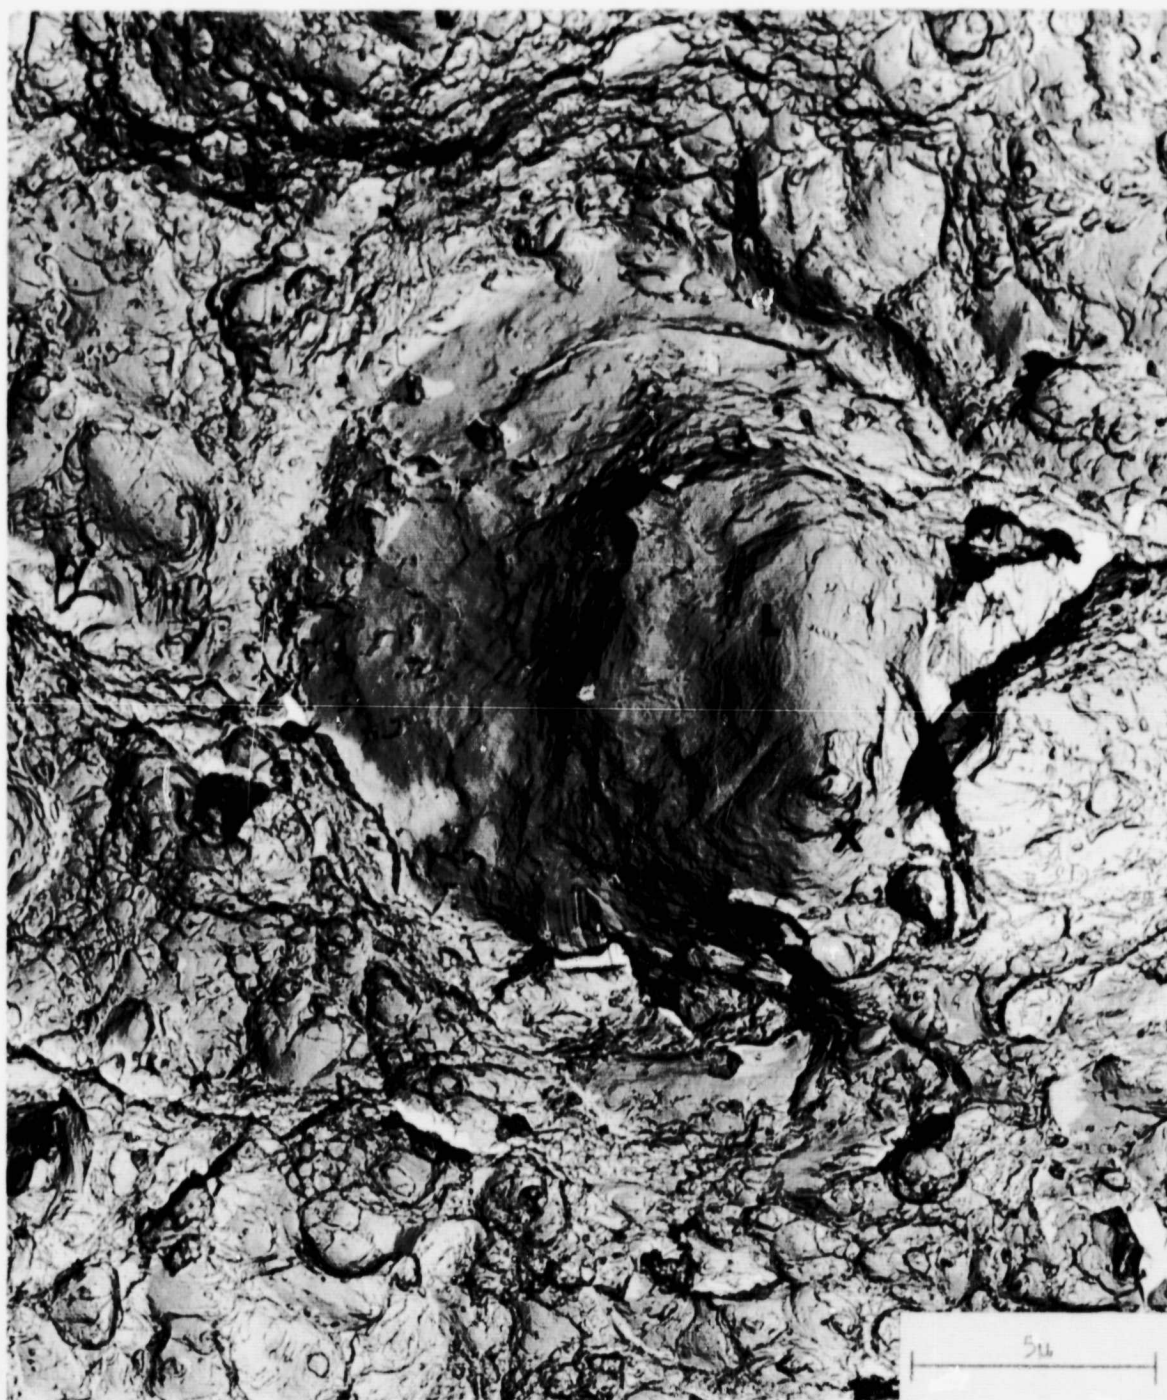
(Large Dimple indicated by L; Nucleating Particle indicated by X)

Figure 9 Electron Fractograph of Two-Stage Replica from Central Region of Tensile Fracture in High Purity AISI 4340 Steel

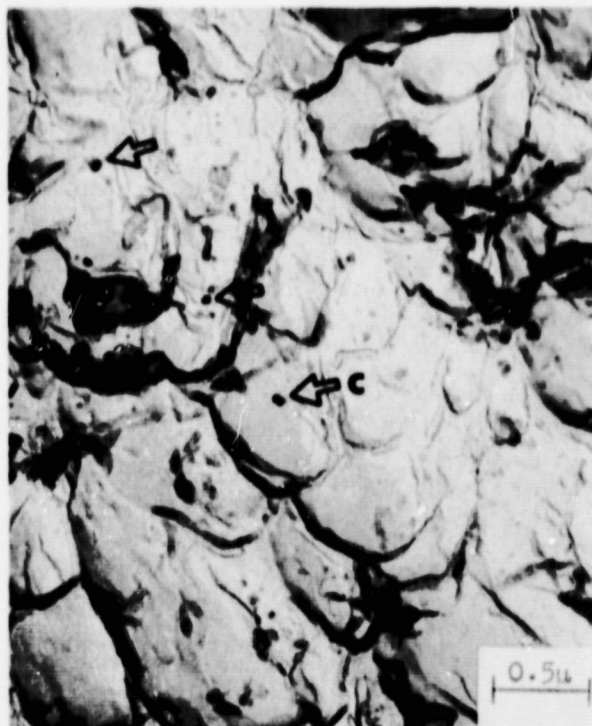
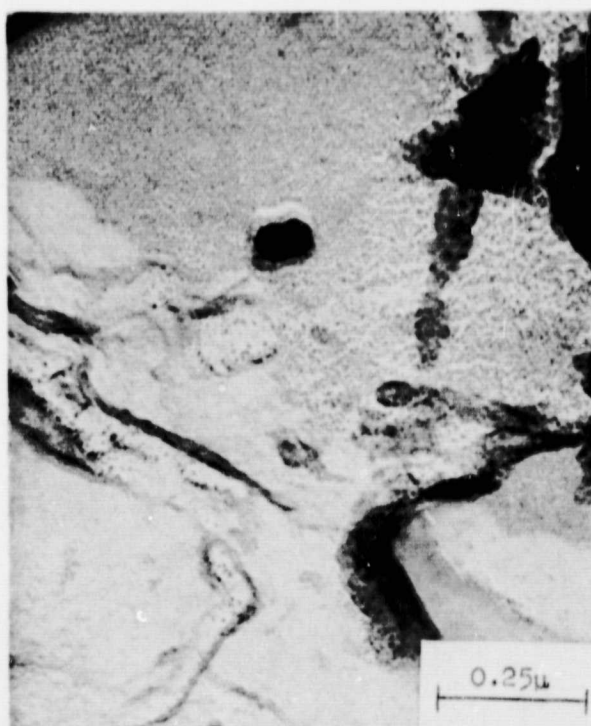
Figure 10 Electron Photomicrographs of Extraction Replica from Commercial AISI 4340 Tensile Fracture

of both commercial and high purity AISI 4340 alloys. An example of an extraction replica taken from the commercial alloy is presented in Figure 10a. Examples of extracted particles are indicated by the arrows on the fractograph. In order to identify the particles, electron diffraction techniques using the electron microscope were employed so that individual particles associated with the small dimples could be examined. The particle marked "C" in Figure 10a is shown at high magnification in Figure 10b, and the selected area electron diffraction pattern from this particle is presented in Figure 10c. The concentric ring pattern about the central spot of the diffraction pattern results from the fine grained polycrystalline platinum deposit used to shadow the replica, while the discrete spots in the pattern result from diffraction from the small single crystal particle extracted from the fracture surface. This latter point was verified using dark field microscopy on all diffracting particles. Several selected area diffraction patterns were taken from particles from both high purity and commercial alloys. Based on a previous investigation,<sup>(6)</sup> the carbides in these alloys for the particular heat treatment used were thought most probably to be cementite. The calculated lattice spacings of the planes within the extracted particles producing the spot patterns observed were compared with the reported d spacings of cementite from previous investigations.<sup>(17,18,19)</sup> These results are presented in Table V. The excellent correlation of the lattice spacings of the extracted particles with those of cementite lead to the conclusion that the strengthening carbides in the AISI 4340 alloys must be the nucleating particles for the formation of the small dimples on the fracture surfaces.
